1. REPORT DATE (DD-MM-YYYY) 04-03-2014		2. REPORT TYPE Journal Article		3. DATES COVERED (From - To)	
4. TITLE AND SUBTITLE Microbiologically Influences Corrosion of Pilings				5a. CONTRACT NUMBER	
				5b. GRANT NUMBER	
				5c. PROGRAM ELEMENT NUMBER 0601153N	
				5d. PROJECT NUMBER

# Microbiologically influenced corrosion of pilings

Brenda J. Little, *senior scientist for marine molecular processes,*  
Richard I. Ray, *physical scientist and* Jason S. Lee, *materials engineer,*  
*Naval Research Laboratory, Mississippi, United States*

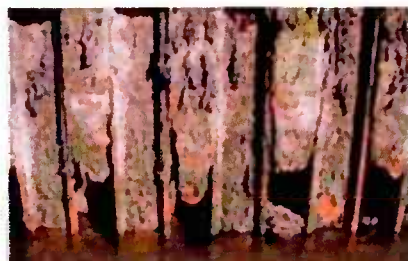
Figure 2a: (Left) Piling deterioration due to ALWC. Figure 2b: (Right) Corrosion of piling in Duluth Superior Harbour.

A report by Gehrke and Sand concluded that ALWC was due to the combination of sulphate-reducing bacteria (SRB) and sulphur oxidising bacteria (SOB) in the fouling layers on the pilings.<sup>6</sup> The organisms co-populate the same spatial regions on the pilings. At low tide the biofouling layer is oxygenated whereas at high tide anaerobic areas develop. Sulphides produced by SRB are converted to sulfuric acid by SOB, creating an extremely corrosive environment. (see Figure 2a).
